114-31-10080

ROUTE CORRECTION

Water body number: 114-31-10080

Survey date: 10/2/2014

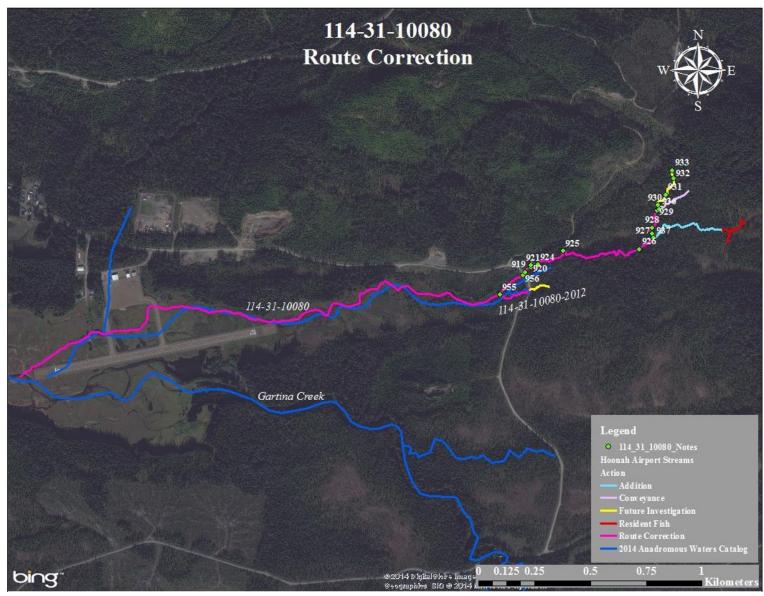
Findings: We surveyed Stream No. 114-31-10080 using an electrofishing unit and GPS. We found the current track for this stream is incorrect and coho salmon utilize areas upstream of the current documented point of anadromy.

Figure 4.—Stream No. 114-31-10080 route correction map.

Recommendations: Update the stream route and extend the upper extent of anadromy for Stream No. 114-31-10080.
